# Petersen Mountains Spring Protections Project Report

<b>Project</b>	Petersen Mountains Spring Protections	<b>Total Acres Protected</b>	0.8 acres
<b>Dates Implemented</b>	July 2024	<b>Total Linear Feet of Fence</b>	1,170 feet

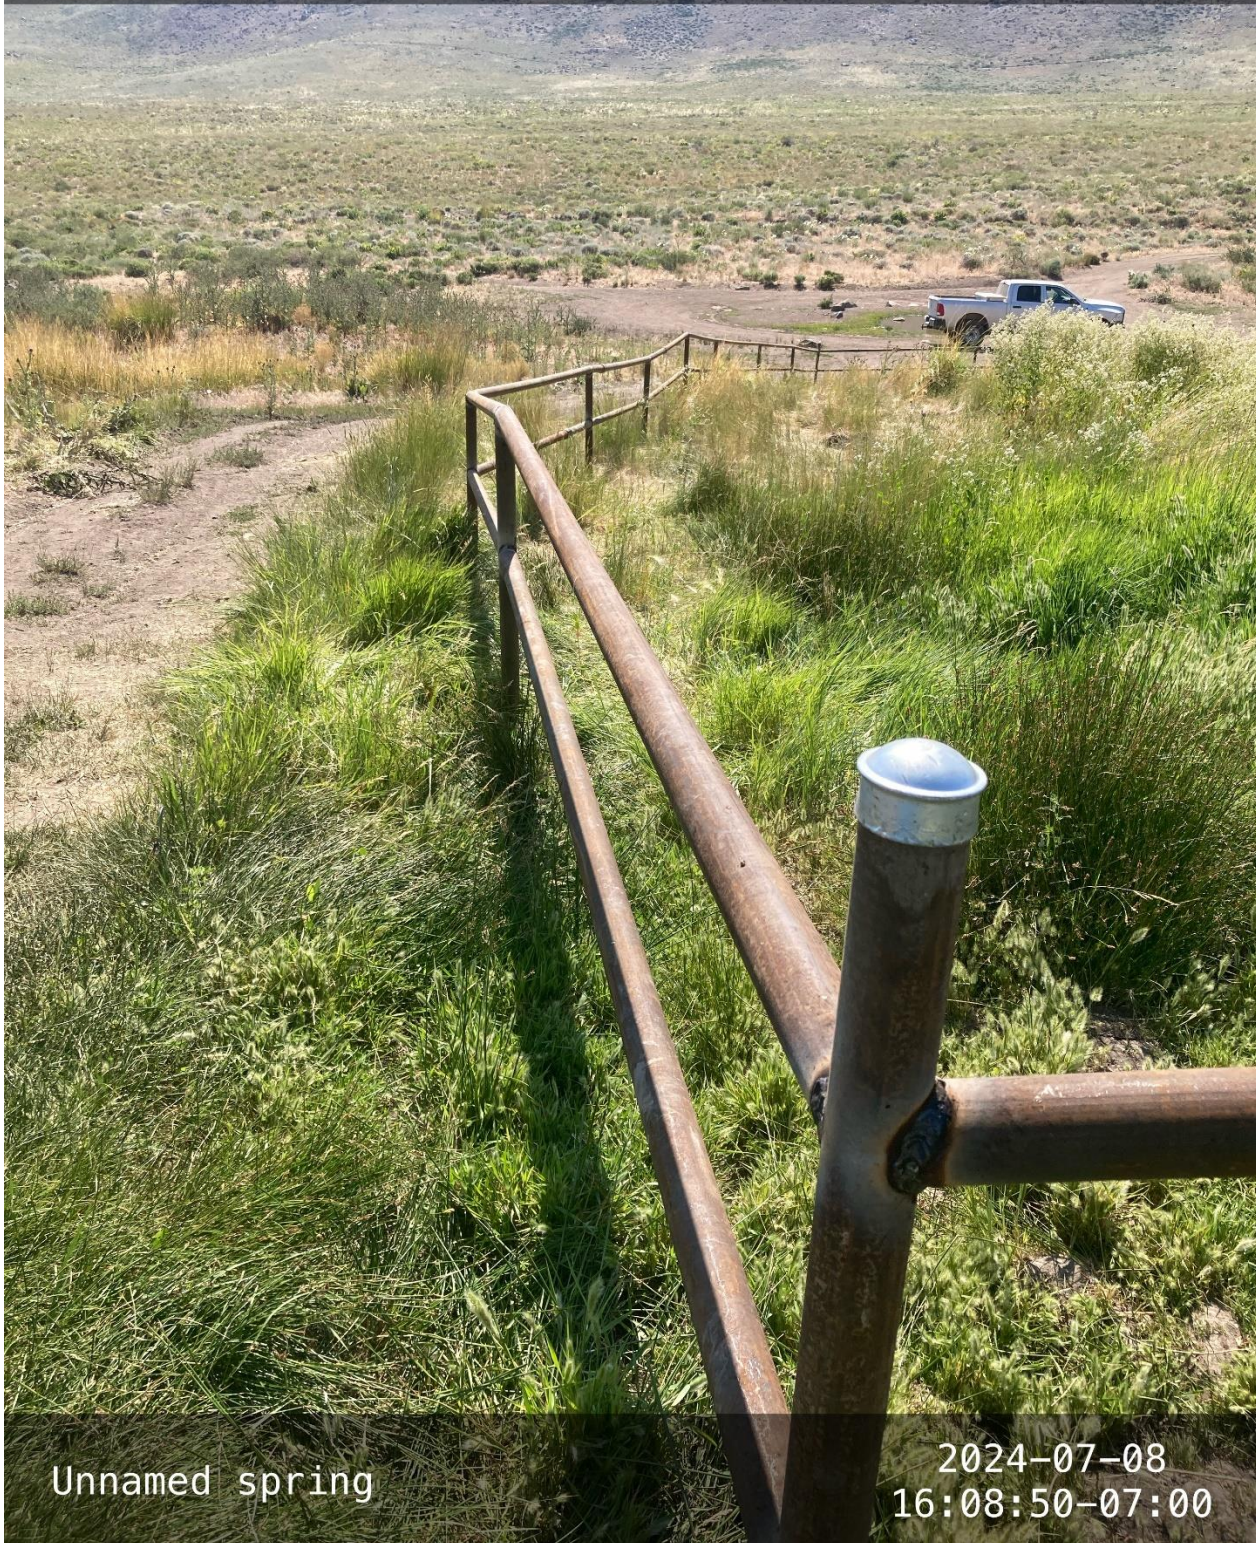
Unnamed spring

Figure 1. Photo of unnamed spring with welded pipe rail fencing.

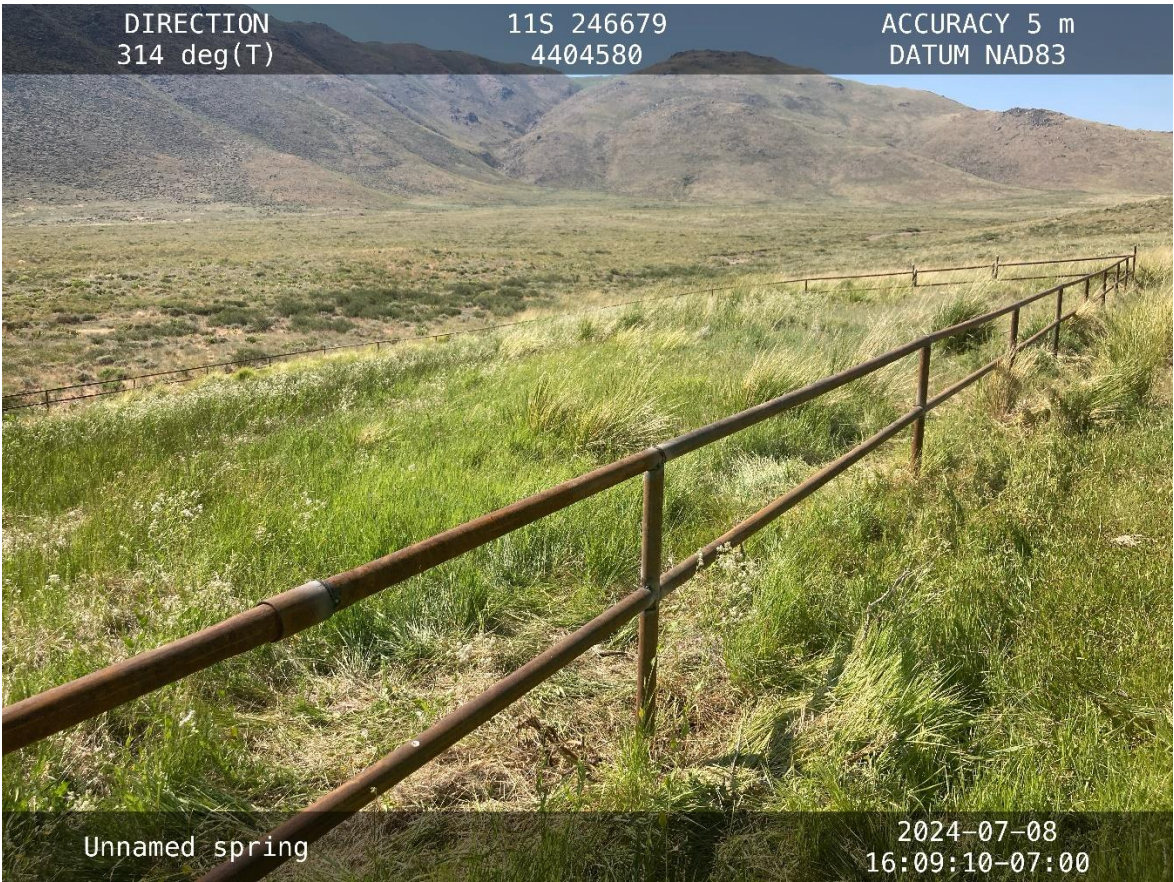
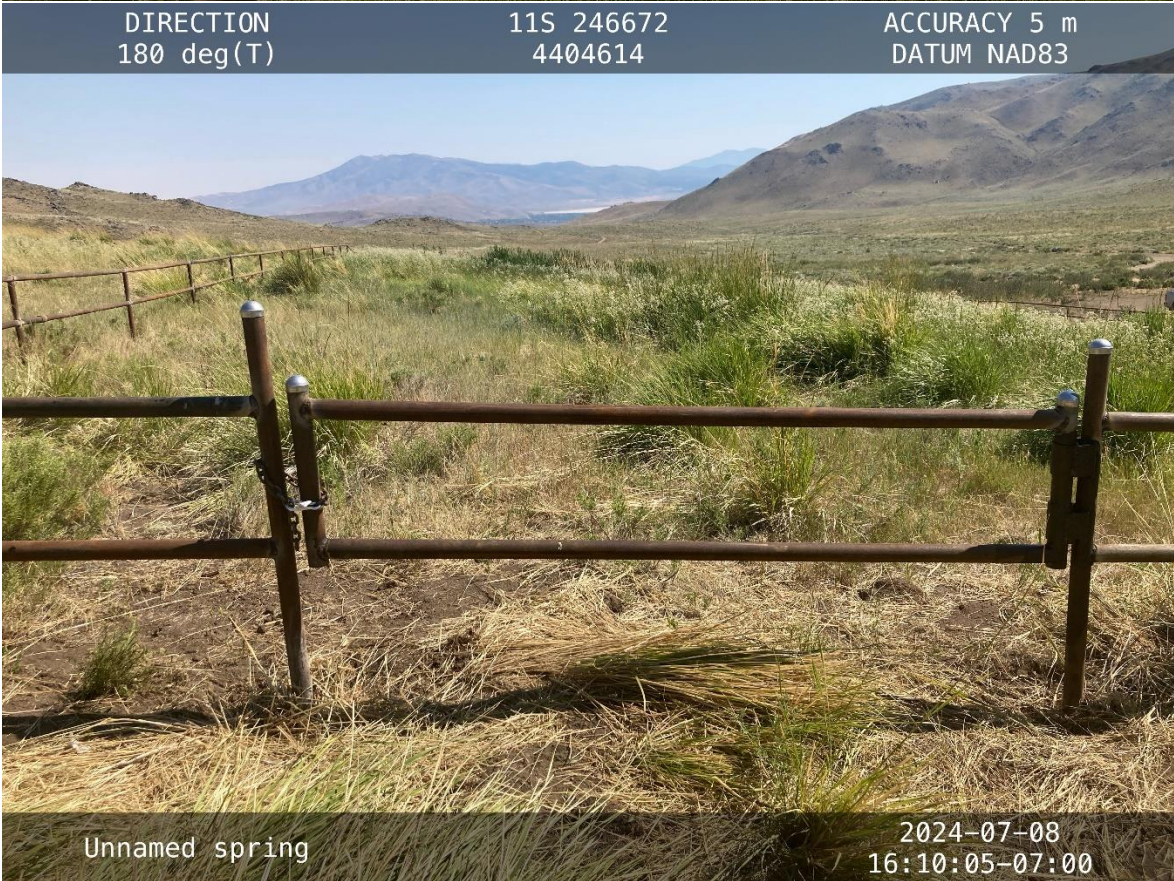
Figure 2. Photos of unnamed spring with welded pipe rail fencing.

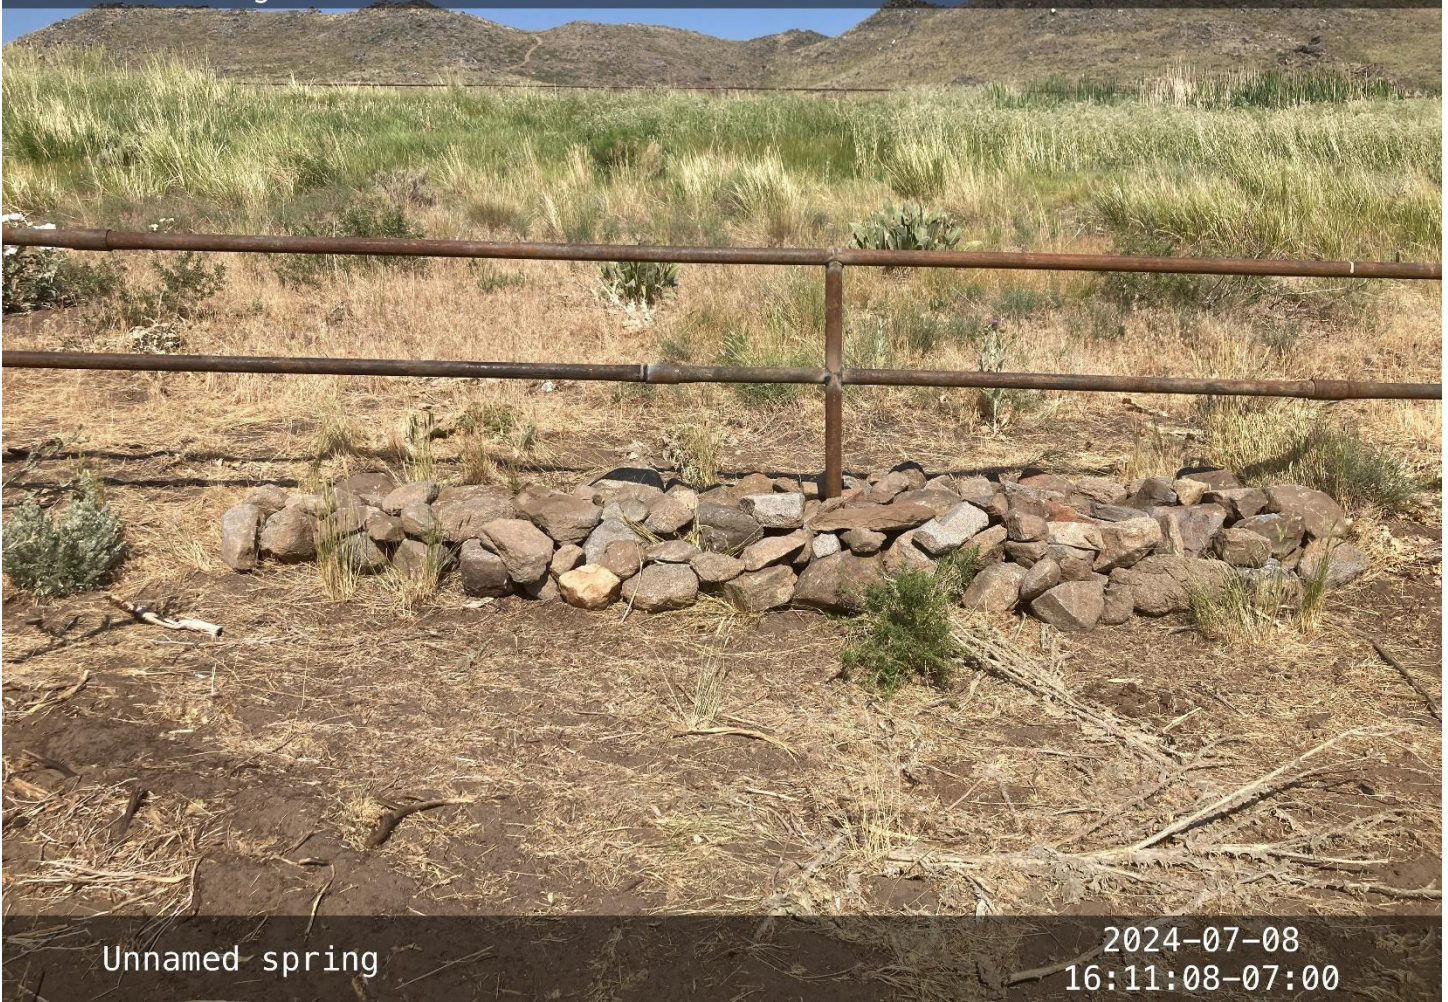
Figure 3. Photo of unnamed spring with welded pipe rail fencing.

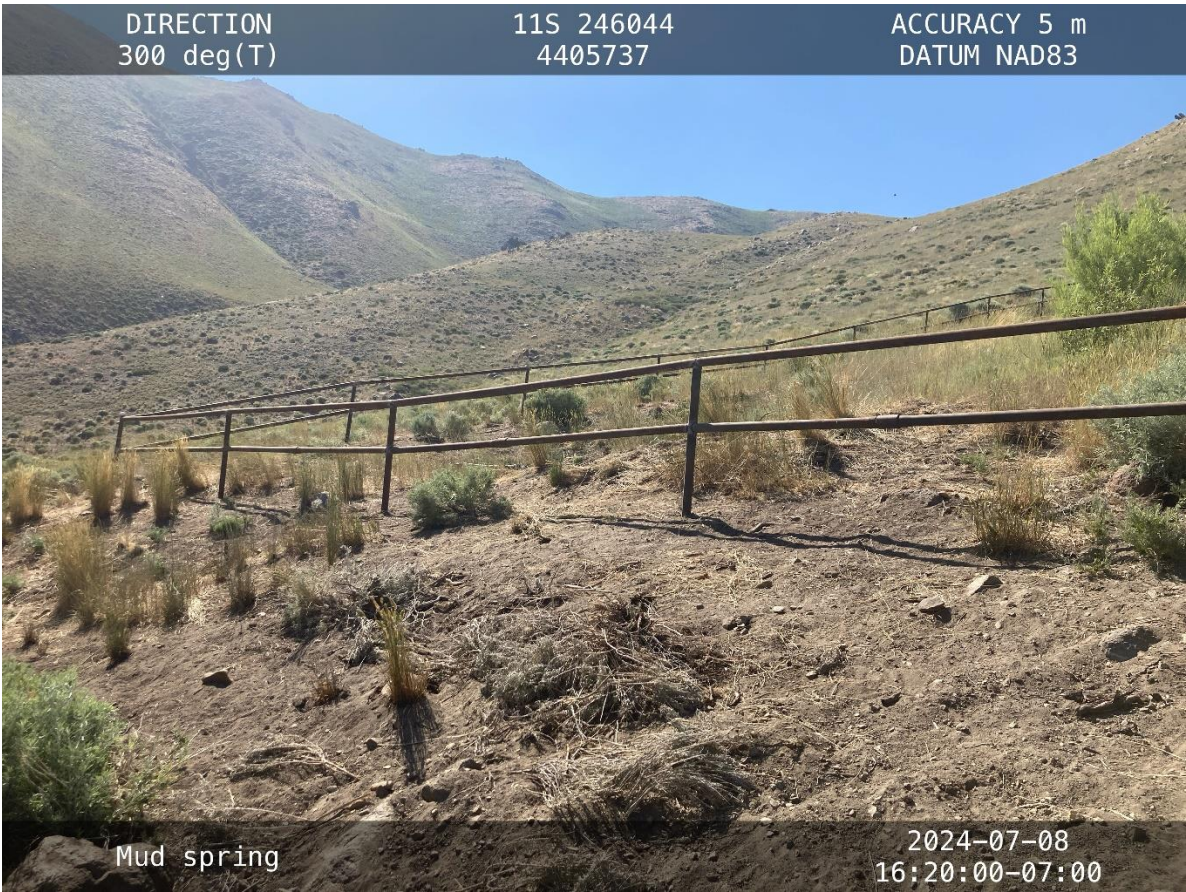
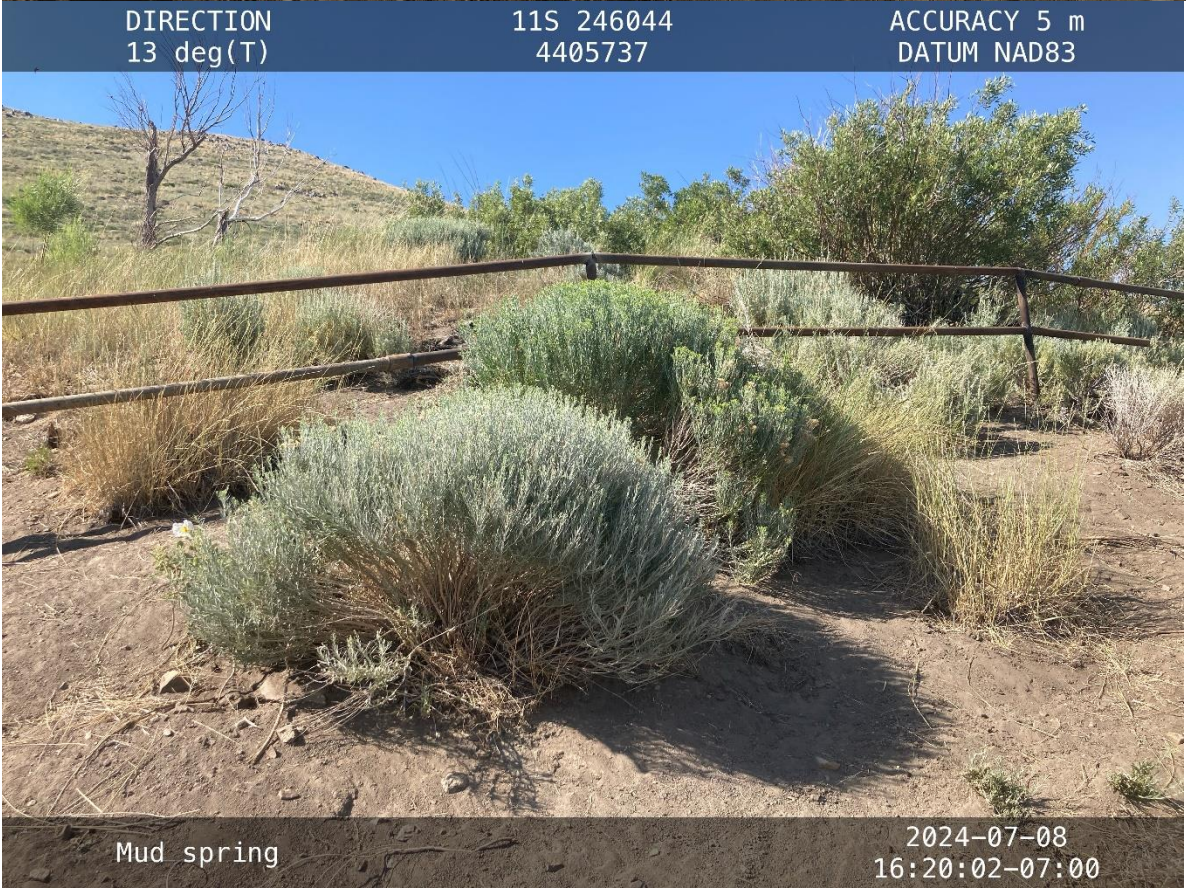
Figure 4. Photos of Mud spring with welded pipe rail fencing.

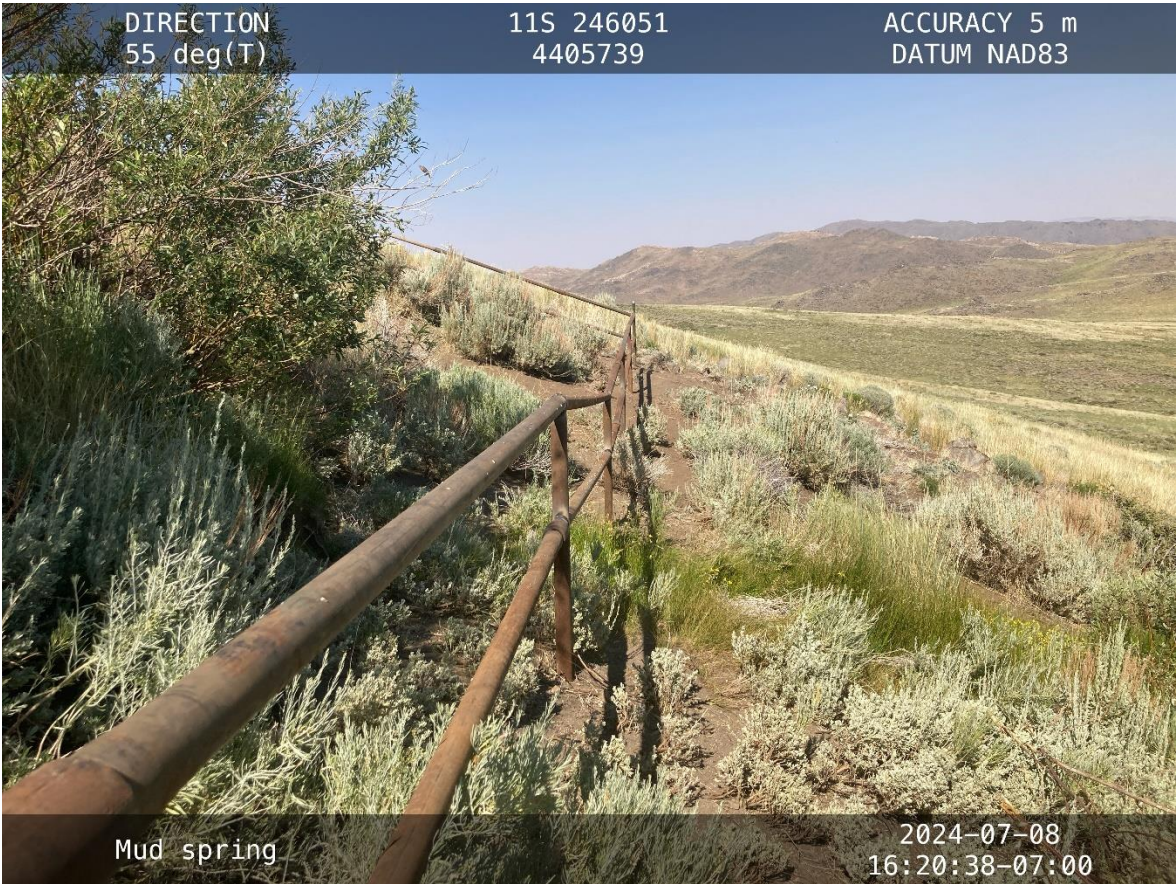
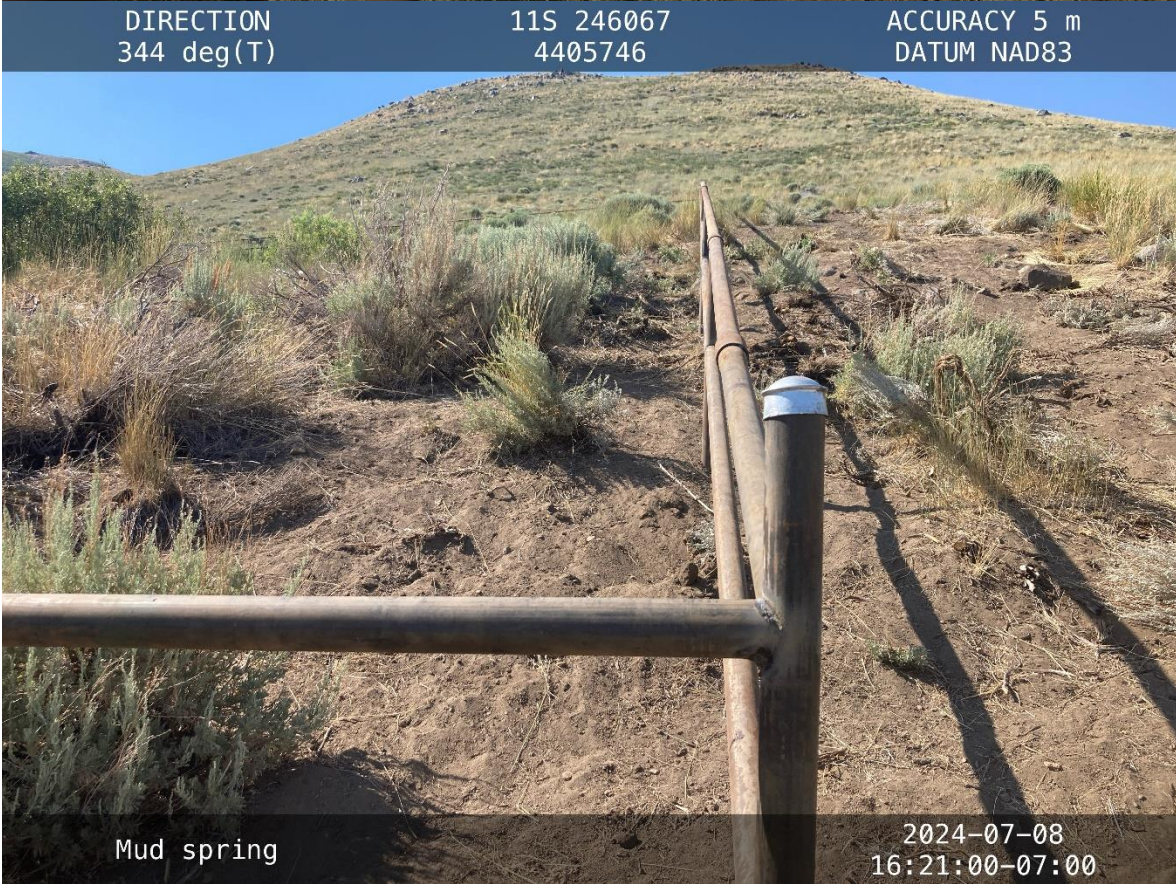
Figure 5. Photos of Mud spring with welded pipe rail fencing.
